# Lake Gaston Association

## 2020 NCSU Summary

April 7th, 2021

Extension Associate, Lake Gaston  
Aquatic Plant Management Program

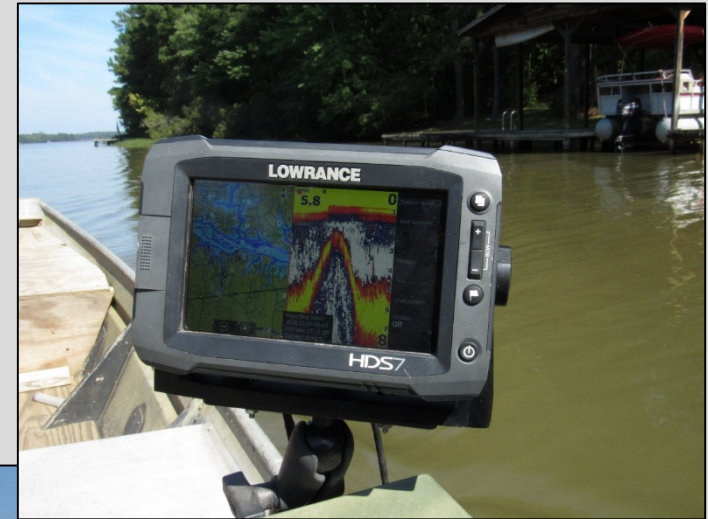
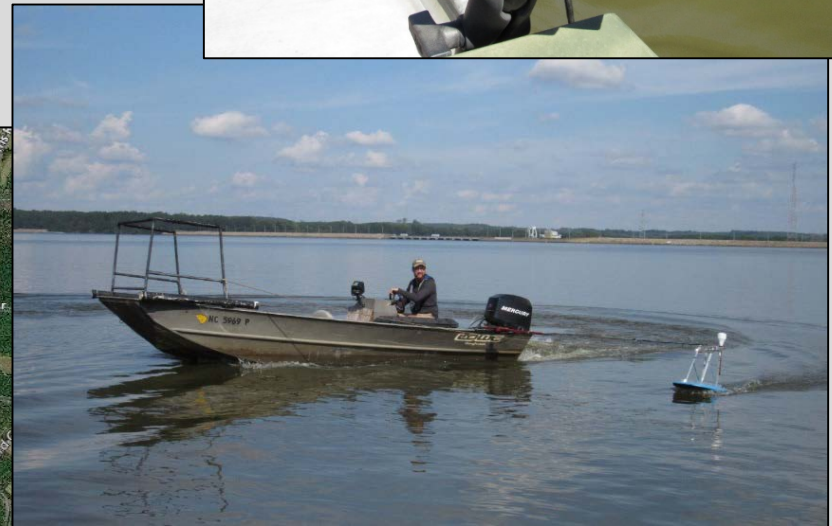
# Fall Sonar Survey

- Entire Shoreline Sampled
- Dual Track Sonar
- September and October
- Data uploaded to BioBase
  - Calculate BioVolume
